**The R.C. Church of Sacred Heart, Hook**  
Quinquennial Inspection Report  
August 2026

for the Roman Catholic Parish of Sacred Heart  
and Diocese of Portsmouth

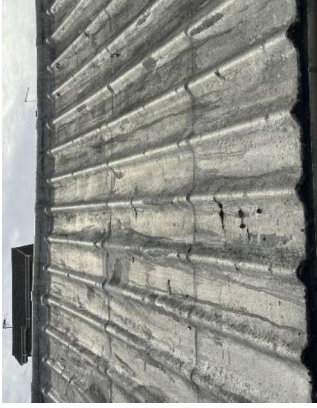
| <b>4.0</b> | <b>Condition Schedule R.C. Church of the Sacred Heart.</b> | | | | | |
|---|---|---|---|---|---|---|
| 4.1.1 | General view of roof | The profiled asbestos sheeting is overlaid with what appears to be a fibreglass reinforced liquid coating. This is starting to fail in way of fixings and some joints where the covering has ruptured. The underlying roofing is uninsulated and its fixings are likely to be starting to fail. | A full replacement roof is likely to be needed in the next 5-10 years, however this is likely to be a very significant undertaking due to the manner of its construction. | £100,000 | E | |

Church - Replace the roof to the church with a modern method of construction. To include for removal and disposal of asbestos by approved contractor

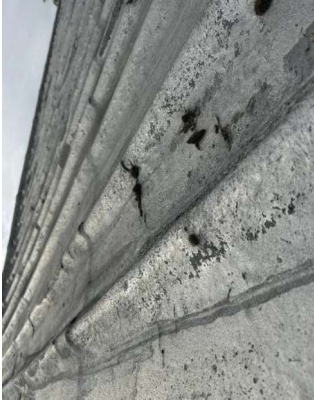
| <b>4.0</b> | <b>Condition Schedule R.C. Church of the Sacred Heart.</b> | | | | | |
|---|---|---|---|---|---|---|
| 4.1.2 | Closer view of roof | The reinforced liquid coating appears to be well stuck, but has ruptured in the location of fastenings and joints between sheets where there has been movement. | The coating needs to be overlaid with a further coating in order to maintain the watertight integrity of the roof, however this is a holding measure for the total replacement that is needed. | 20,000 | B | |

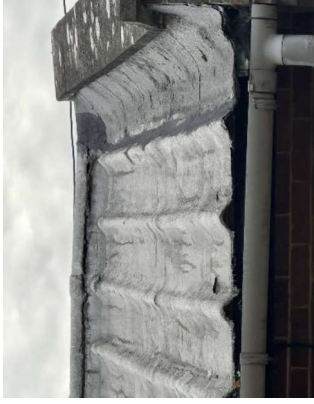
| 4.1.3 | North end, parapet junction. | The abutment with the parapet has been made up with mineral faced felt with some additional detailing at the ridge. This detail is workmanlike but should only be seen as a holding measure. | Area should be overcoated as part of 4.1.2 and would also be replaced as part of 4.1.1 | Included in 4.1.1 and 4.1.2 | B, E | |

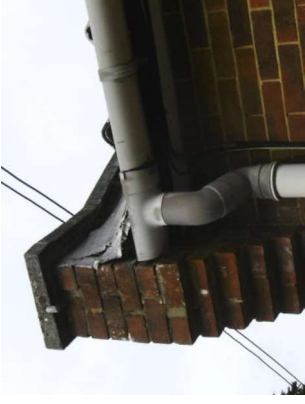
| 4.1.4 | North end, parapet weathering, west side | Layering of felt is visible in this photo and badly adhered. | As 4.1.3 | Included in 4.1.1 and 4.1.2 | B, E | |

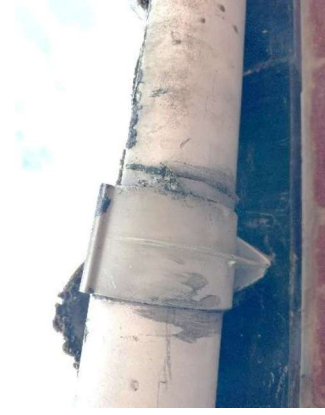
| 4.2.1 | East side | Gutter has pulled out of joint – due to age many fittings are now difficult to maintain | Re connect the joint, mindful that fittings are brittle | £100 assuming ladder access | M<br> |

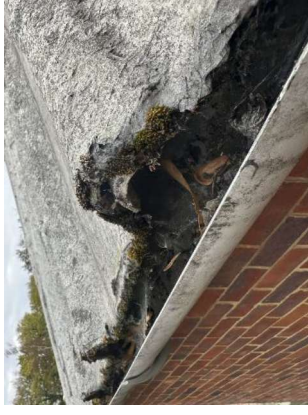
| 4.2.2 | Guttering generally | The guttering is now quite aged and brittle, not broken bracket in photo. Also in need of cleaning | Clean guttering<br>Replace guttering in next 5-10 years | £500<br>£4000 | M<br>D<br> |

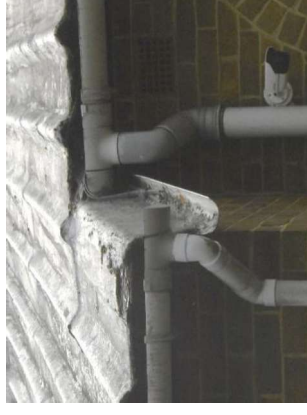
| 4.2.3 | Verge detail at step in plan (sanctuary) | Verge has a bonded-on gutter which drains directly onto the ground | Install hopper and connect into downpipe | £500 | E<br> |

Church - remove redundant gutter to both sides of the church and replace with a lead angled fillet to direct water into gutter at the roof verge.

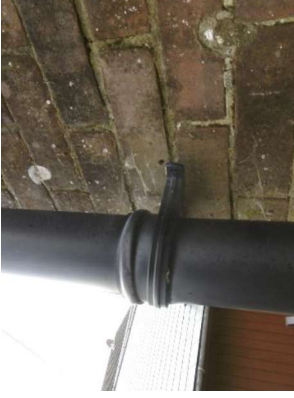
| 4.2.4 | Soil pipe on south west corner | uPVC soil pipe appears to be a relatively recent replacement. One bracket screw is missing | Refix bracket | £0 – assuming DIY | M | |

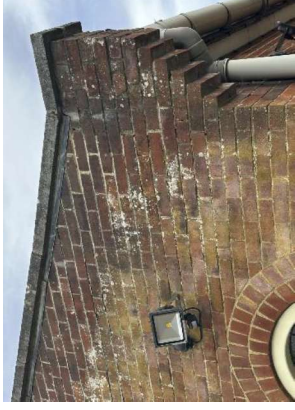
| 4.5.1 | North gable | North gable is the formal elevation (liturgical west) with corbelled springers to each side picking up the end of the concrete copings. The brickwork has cracks running along the bed joints suggesting some instability in these features to both sides. | Allow for raking out and the installation of helical ties within the bed joints, localised repointing etc. Specification required from structural engineer. | £3500 | C | |

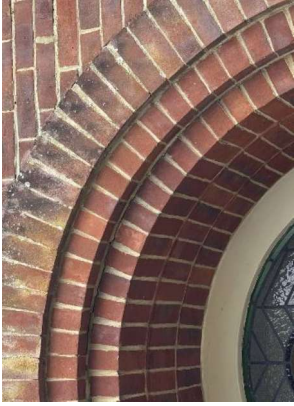
| 4.5.2 | West door arch | Cracking to brickwork joints is visible where voussoirs have settled. | Monitor – should be inspected by a structural engineer | £2500<br>(structural inspection – also covering other items) | B | |

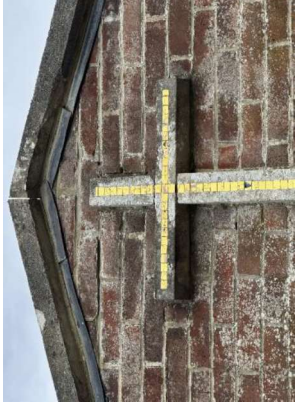
| 4.5.3 | South elevation | Parapet coping has open joint at apex | Fully fill joint with flexible mastic sealant. | £250 | C | |

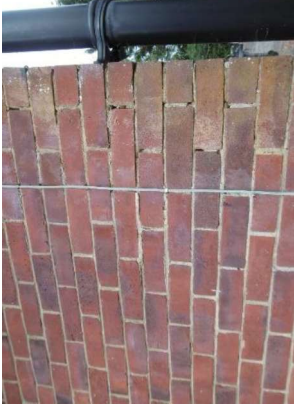
| 4.5.4 | South west corner | Open brick joints | Rake out locally and repoint in matching mortar. | £1500 | D | |

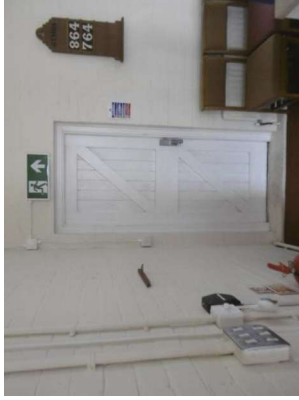
| 4.7.1 | <p>Sanctuary (fire escape)</p> <p>External door (fire escape) has suitable escape ironmongery and is in good condition, but the threshold is a trip hazard.</p> | <p>Add clear demarcation or a ramp.</p> <p>£150</p> <p>B</p> |

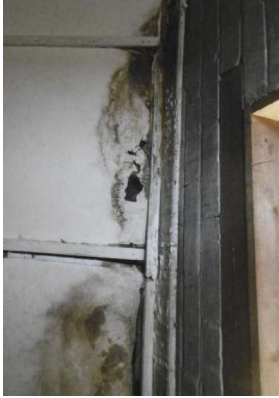
| 4.8.1 | Loft space | This ceiling has badly stained section by the cross wall which appears to be from an historic? roof leak. | Assuming this is historic, no action is necessary. This should be monitored. | | M | |

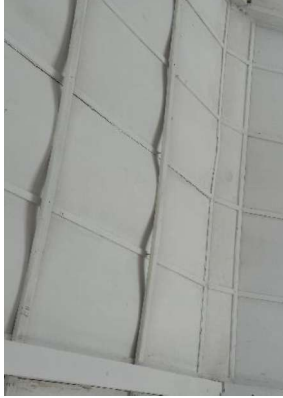
| 4.8.2 | Nave | Battens securing ceiling are screwed into the timber ribs that cover panel joints and presumably align with the rafters. However this detail should be checked. The screw shanks are exposed, is this due to slippage or are they not fully tightened? | The fixings need to be considered and checked by a structural engineer.<br><br>Consider replacement ceiling in plasterboard as part of wider roof and insulation works | Included with 4.5.2<br><br>£25000 | C<br><br>E | |

Church - redecorate ceiling in the nave, to include for stain block where stained due to condensation; redecorate rear internal wall to chancel to remove staining.

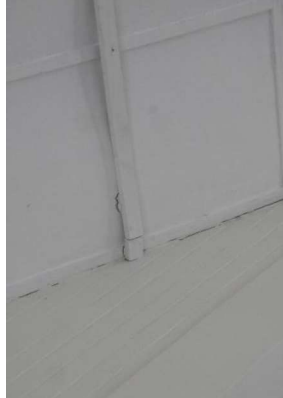
| 4.8.3 | Nave, west side adjacent to sanctuary cross wall | Crack in batten | Check and replace | £250 | A | |

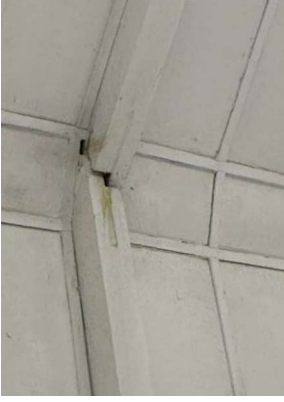
| 4.8.4 | Nave portal frame connection | Midway down the nave is a joint in the concrete frame which is stained, there appears to be fine crack on the west frame - this should be checked for any issues | Structural inspection of issue | Included with 4.5.2 | B | |

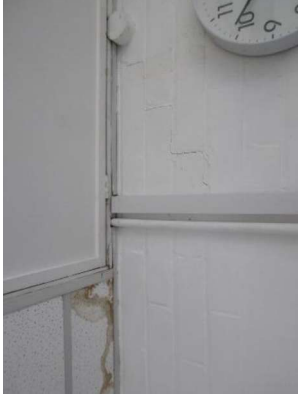
| 4.9.1 | Sacristy | The cross wall in the Sacristy, (directly below item 4.8.1) shows some stepped cracking. This should be investigated. Note staining on ceiling from roof leak. | Allow for structural inspection | Included with 4.5.2 | B | |

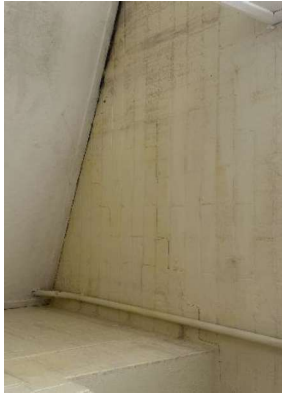
| 4.9.2 | Confessional | Evidence of severe condensation on north wall and ceiling | Clean down and redecorate locally | £500 | B | |

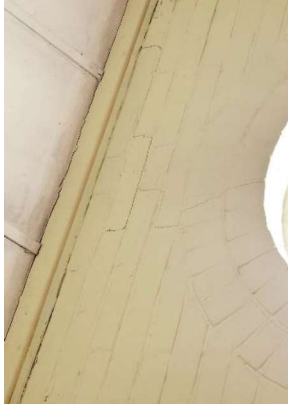
| 4.9.3 | Nave - east wall | Cracking to window head and brickwork above | Allow for structural inspection, monitor during next quinquennium | Included with 4.5.2 | B | |

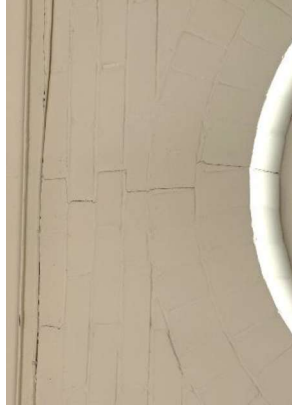
| 4.9.4 | Nave - east wall | Cracking to window head and brickwork above | Allow for structural inspection, monitor during next quinquennium | Included with 4.5.2 | B | |

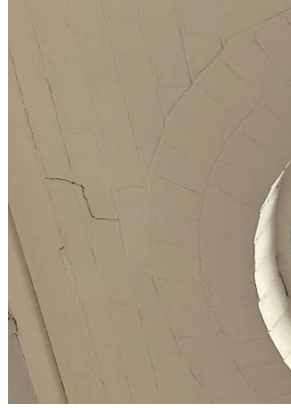
| 4.9.5 | Nave - west wall | Cracking to window head and brickwork above | Allow for structural inspection, monitor during next quinquennium | Included with 4.5.2 | B | |

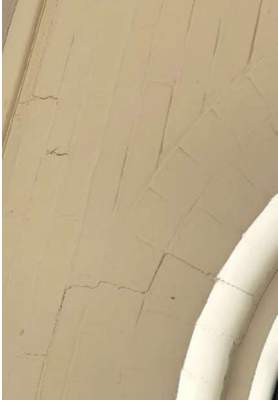
| 4.9.6 | Nave – west wall | Cracking to window head and brickwork above | Allow for structural inspection, monitor during next quinquennium | Included with 4.5.2 | B | |

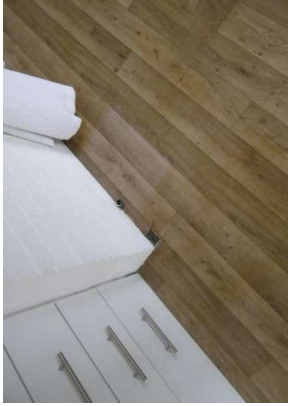
| 4.10.1 | Sacristy | There is a notch out of the floor covering. | Glue in patch of matching vinyl | £50 | M | |

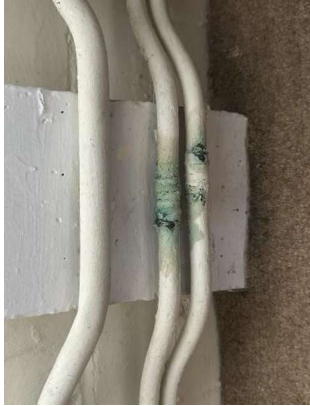
| 4.13.1 | Heating pipe joints | The flow and return pipes are cranked round each of the portal frame uprights. There are several locations where there appears to be leakage at joints. | Carry out review of leaks and repair | £2500 | C | |

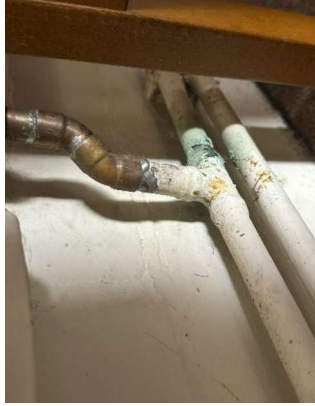
| 4.13.2 | Heating pipe joints | This example is similar to the above but concerns a section that has also had a recent repair. | Carry out review of leaks and repair | Included with 4.13.1 | C | |

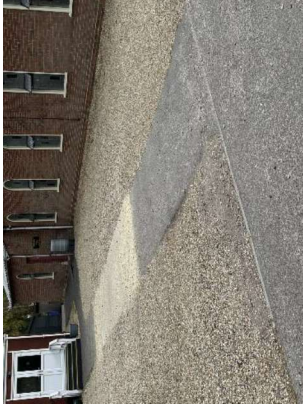
| 4.17.1 | Edge of tarmac path | There is a change in level between the path and gravel to the east of the church. This should be filled in. | Level up gravel. | £0 DIY | M | |

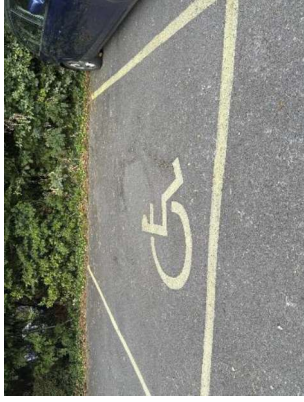
| 4.17.2 | Disabled parking space | The disabled parking space to the east of the church has been subject to some heave by tree roots, presenting a trip hazard. | Level off and repair surface. | £1500 | E | |

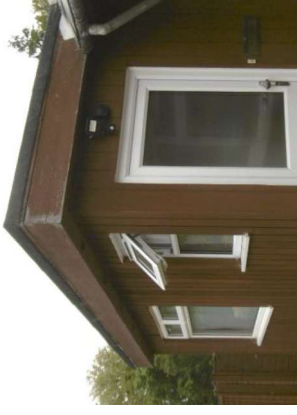
| <b>Condition Schedule The Presbytery</b> | | | | | |
|---|---|---|---|---|---|
| 5.1.1 | Flat roof soffits | Soffits are in timber finished with wood stain. | Redecorate. Some repairs may be needed | £1,000 | M |

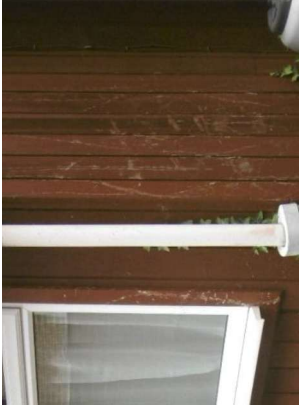
| 5.5.1 | External boarding | Some redecoration is needed where foliage has been removed from the cladding. | Redecorate within 2 years | £4,000 | M |

Presbytery - replace timber trim to windows where currently missing. To include for realigning slipped cladding above windows and replacing missing cladding.

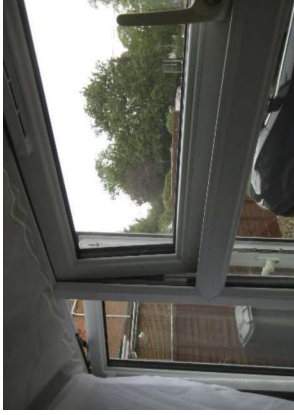
| 5.6.1 | North elevation | The opening transom light was not closing properly | Hinges / latch needs to be adjusted by a glazier | £200 | A |

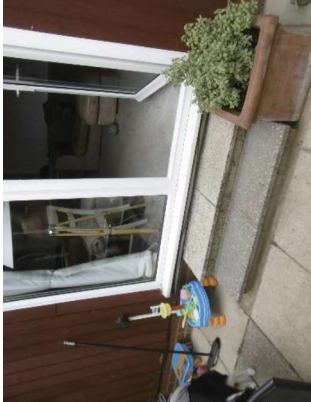
| 5.11.1 | Steps to south elevation | There are steps from the patio doors. These stop short of the doors on both sides, and while there is a large plant pot located to the side of the opening door, this arrangement presents a risk. | Steps should be widened to exceed width of opening door(s) | £1000 | B |

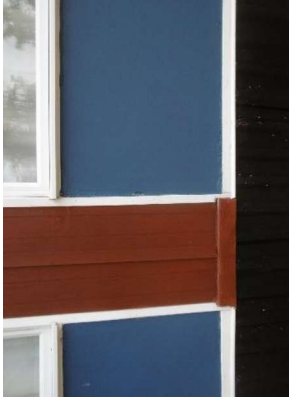
| <b>Condition Schedule The Parish Hall</b> | | | | | |
|---|---|---|---|---|---|
| 6.5.1 | Timber cladding panels | Some of the panels are starting to delaminate and are likely to need replacement in the next 5 years. | Allow for installation of some replacement panels where required, and redecoration where required. | £2500 | D |

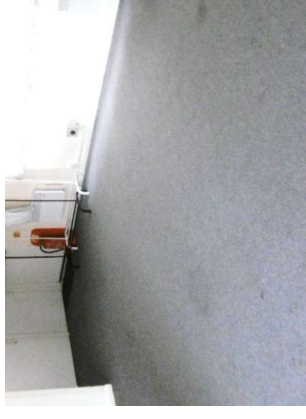
| 6.10.1 | Hall carpet | The carpet is in generally good condition but there are a few stains. | Carpet should be deep cleaned to improve appearance | £250 | B | |

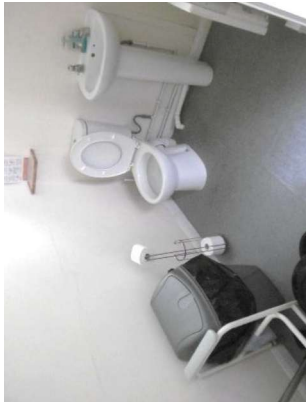
| 6.13.1 | WC | WC should be cleared of stored items etc that inhibit its use as an AWC.<br>Grab handles and other Part M compliant fittings could be added to improve it. | Clear items<br>Consider improvements to its accessibility | £0<br>£500 | A<br>E | |

Church Hall - Replace worn floor coverings to WC and kitchen area.

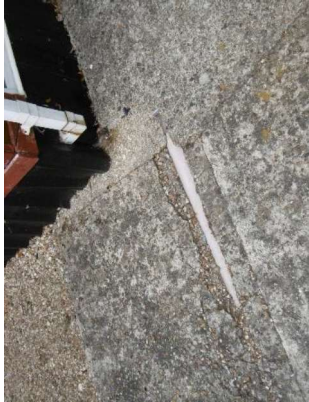
| 6.13.2 | Foul drainage | The foul drainage pipe is partially exposed and is too shallow. | The pipe should be dug out buried at a compliant level. | £2000 | B | |
