**The R.C. Church of Sacred Heart, Hook**  
Quinquennial Inspection Report  
August 2026

for the Roman Catholic Parish of Sacred Heart  
and Diocese of Portsmouth

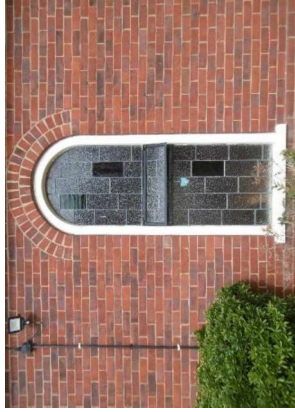
| 4.6 | <p><b>Windows and Glazing</b></p> <p>The glazing to the church is in Crittall-type steel casements set within concrete surrounds. These have leaded-light glazing and top-hinged opening sections at half-height. There are uPVC windows to the south elevation serving the Sacristy and parish office.</p> <p>The windows and glazing appeared to be in good condition generally and should need no further work during the next quinquennium beyond general maintenance.</p> | |

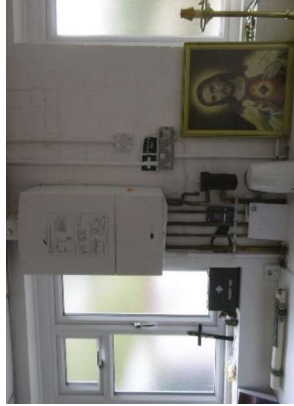
| 4.13 | <b>Heating</b><br>The church is heated by a Worcester Bosch gas fired condensing boiler located on the south wall of the sacristy, providing hot water to conventional steel panel radiators mounted at low level on the walls of the church. The system was not tested during our inspection. | | | | | |

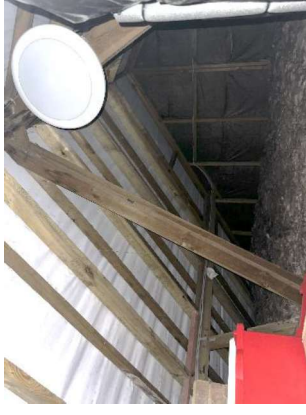
| <b>Condition Schedule The Presbytery</b> | | | | | |
|---|---|---|---|---|---|
| | <b>Roofs</b><br>The roof is in artificial slate (replaced since the last QI report) and there is a flat roofed extension in bituminous felt. Roofs couldn't be inspected in detail due to there being no external access available.<br><br>A limited inspection was carried out within the principal roof space. The roof is lightly constructed with a modern breathable felt sarking. There is fibreglass wool insulation at ceiling level. No issues were noted. | | | | |

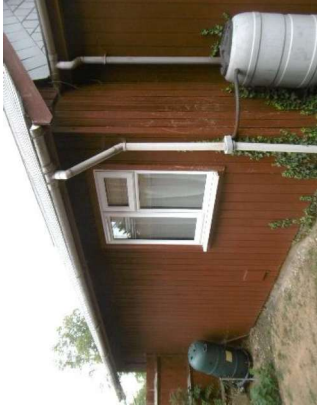
| <b>Condition Schedule The Presbytery</b> | | | | | |
|---|---|---|---|---|---|
| | <b>Rainwater drainage</b><br>The rainwater goods are in grey uPVC, half round profile with circular downpipes. There is a waterbutt, which is a risk with a timber clad building and should be monitored for overtopping and leakage. The rainwater goods are now of some age, but no defects were noted. | | | | |

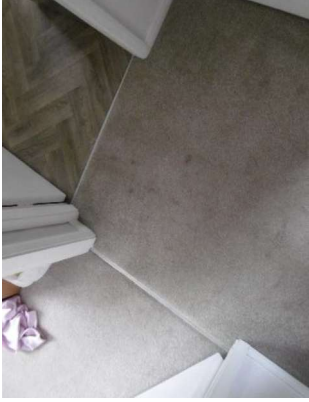
| <b>5.10</b> | <b>Floors</b><br>The floors to the presbytery are suspended floors, overlaid with carpet throughout, with exception to the kitchen and bathroom, which have vinyl floor finishes.<br>The floor finishes appear to have been recently replaced, there are some signs of soiling and it was noted that the tenant has a dog at the property. | | | | |

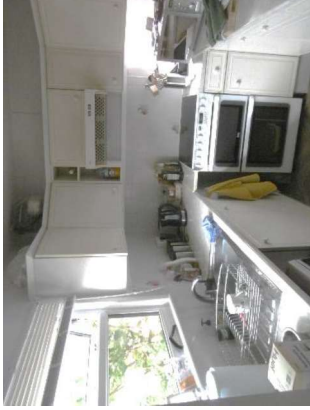
| 5.12 | <p><b>Kitchens</b></p> <p>The kitchen is well appointed and located to the north east of the property. No issues were noted.</p> | |

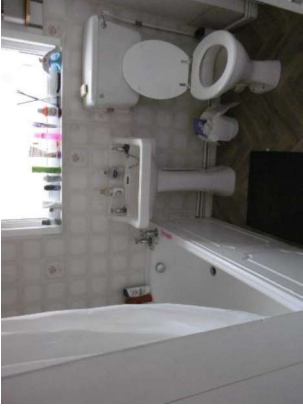
| 5.13 | <p><b>WCs and bathrooms</b></p> <p>The bathroom has a basin, WC and shower over the bath. There were no issues noted, but the an over bath shower is not ideal in a rental property due to a risk of leaks and as such should be carefully monitored.</p> | |

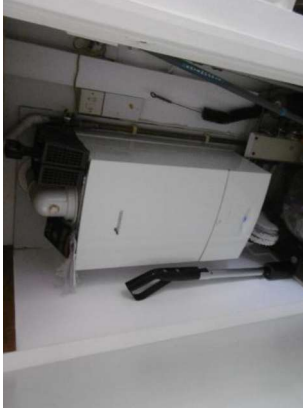
| 5.14 | <p><b>Heating</b></p> <p>There is a Worcester Bosch condensing gas boiler providing heating to radiators and domestic hot water by way of a Gledhill hot water cylinder. No issues with the system were reported, but it was not inspected or tested.</p> | |

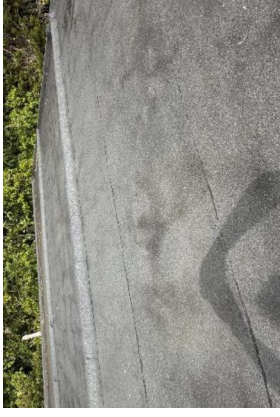
| <b>Condition Schedule The Parish Hall</b> | | | | | |
|---|---|---|---|---|---|
| <b>6.1</b> | <b>Roofs</b><br>The roof to the church hall is a flat roof with upstands about the perimeter and at each bay (dividing the roof into three). The roof is overlaid in mineral faced bituminous felt with drainage outlets to both sides, there is a slight fall to the front (north) side of the building. There is poor detailing of the drainage outlets to the rear. The roof covering appears to be in fair condition. No works appear to be needed within the next quinquennium beyond normal maintenance. | | | | |

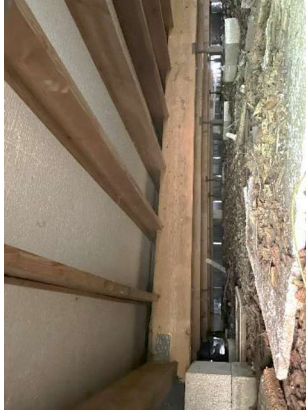
| <b>6.10</b> | <b>Floors</b><br>The floor is constructed over joists spanning between the principal beams which are set onto pedestal jacks on concrete block pads. There is a layer of polystyrene insulation between the joists. The floor coverings are carpet to the main hall and vinyl to the kitchen and WC. These surfaces are all in serviceable condition. No inspection was made of the underlying floor, assumed to be plywood or chipboard. | | | | | |

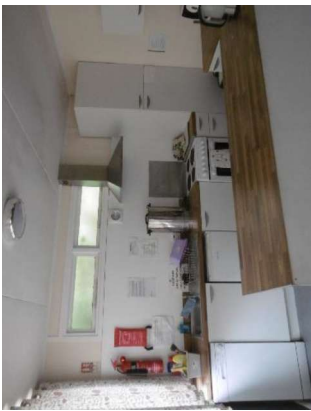
| 6.12 | <b>Kitchen</b><br>The kitchen has low level units, and a 'peninsular' island /counter top forming a servery. There is a free standing oven and hob with extract fan, a small fridge and dishwasher. There is an additional small mechanical extract vent adjacent to the extractor hood.<br>The kitchen appeared suitable for its purpose and no significant issues were noted. | | | | | |

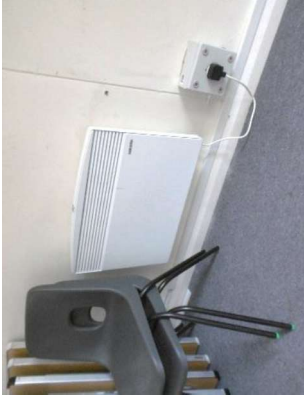
| <b>6.14</b> | <p><b>Heating</b><br/>The building is heated via three wall mounted electric radiators in the main hall space, and a further small electric radiator in the WC.</p> <p>The systems were not inspected as part of this report.</p> | |
